## **Safety Notice for symmetric V-type and asymmetric Y-lanyards**

## Safety Notice for symmetric Y-lanyards

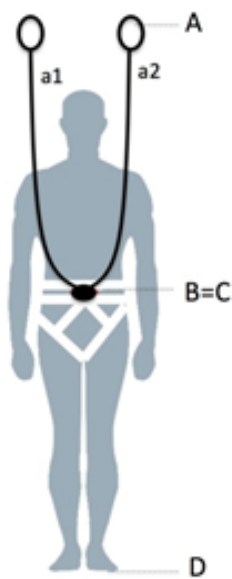
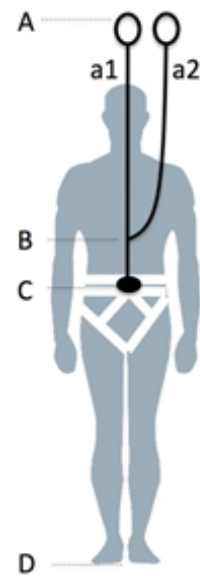
If the individual parts of a fall protection system are setup in a wrong and/or poor configuration, SISKA sees the risk for accidents.

If the system is configured the wrong way, in case of a fall, and the neck of the climber gets between lanyard **a1** and lanyard **a2** it can lead to unconsciousness and death.

SISKA advises that operators, together with the manufacturer and the builder, should assess and evaluate their respective park(s).

Furthermore, SISKA advises that affected manufacturers, dealers and builders reevaluate the system in use, as well as perform a reassessment the risk of the system used.

Inspectors are advised to deliberate this topic upon inspection.

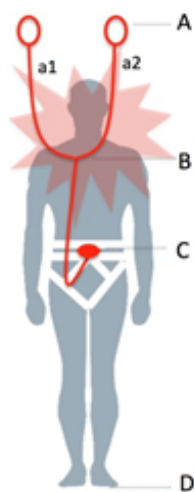
If both arms of a Y-shaped lanyard, **a1** and **a2**, are equally long and attached to the same anchor point/Life Line, danger of an accident is a given.

The reason for this Safety Notice is due to several severe accidents that have occurred: if the neck of the climber gets between lanyard **a1** and lanyard **a2** in case of a fall, it can lead to unconsciousness and death. It is the opinion of SISKA that the root cause is in the configuration and the parts of the safety system.

Manufacturers of such lanyard systems are hereby requested to develop a technical solution and actively inform operators of affected parks about this issue and offer suggested possible solutions.

Operators of affected parks are advised to cease operation until a proper risk assessment and evaluation have been performed.

SISKA advises operators to contact the manufacturer of the lanyard system to assess and evaluate their respective park together with the manufacturer.

Inspectors are advised to deliberate this topic upon inspection.
